MOTOR TERMINAL REPAIRS TO CHHN COMPRESSORS

See Also HCOM-SB-85

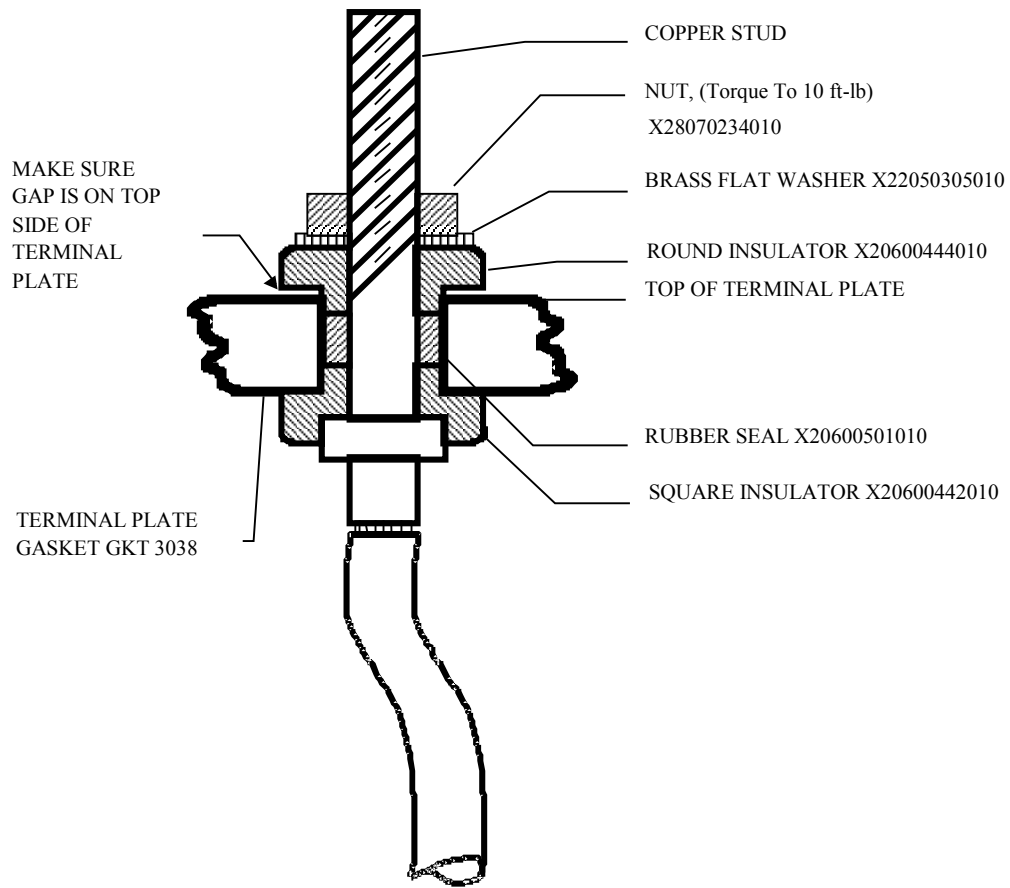
Figure 1
Insulator Section

5. Remove the terminal plate.
6. Inspect components for scratches, etc. that may have caused the leak.
7. Remove lower insulator.
8. Begin reassembly by replacing lower insulators (green) with the square black insulator (make sure the terminal post is seated in the insulator).
9. Replace o-rings with the rubber seal.
10. Oil and install new terminal plate gasket.
11. Carefully push terminals through the terminal plate.

12. Install upper insulator (round, black).
13. Place flat brass washer on top of the upper insulator.
14. Hand tighten the nut.
15. Reconnect the spade connectors for the motor terminal sensors. Follow the color coding of the sensors.
16. Install the terminal plate on the compressor with the 12 mounting bolts.
17. Torque the terminal plate mounting bolts to 40 ft-lb.
18. Torque the terminal stud nuts to 10 ft-lb.

CAUTION: OVER TORQUING THE TERMINAL NUTS MAY RESULT IN BREAKAGE OR LEAKING, OR BOTH.
