General Service Bulletin

RTAA

CHHB Compressor Motor Terminal Rework

Order No: **RTAA-SVB08B-EN**

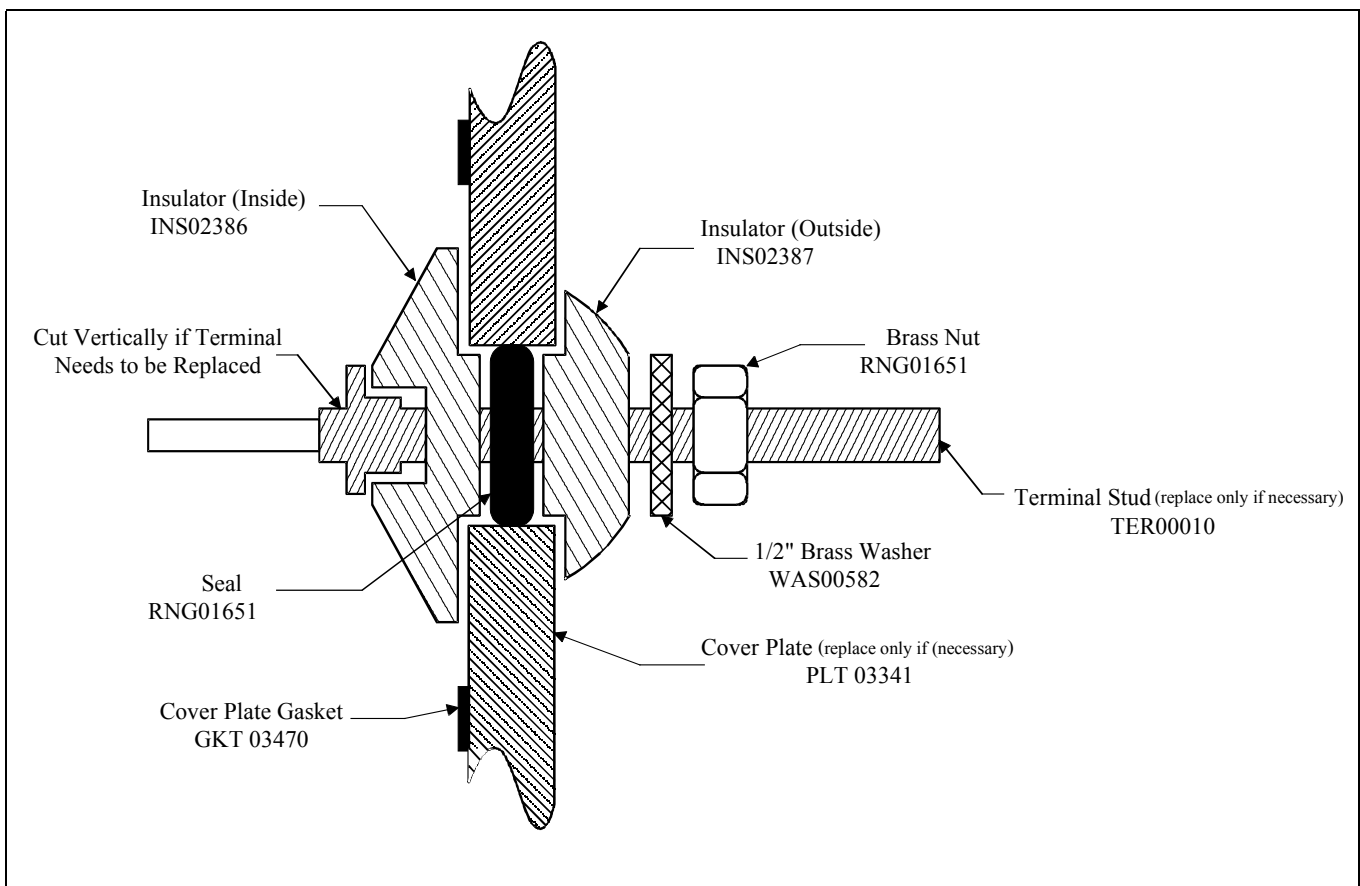
Figure 1: Terminal Cross Section

5. Mark and unplug the motor winding temperature sensors – set the cover plate aside.
6. Remove the remaining insulators.
7. If the terminal is damaged and needs to be replaced go to step 8. If the terminals are in good condition go to step 12.

8. Use a hacksaw or die grinder and cut where specified in Figure 1.
9. Carefully cut the copper jacketed sleeve axially. Care must be taken to limit damage to the metal sleeve on the end of the winding.

10. Spread the sleeve apart and remove. The metal sleeve should still be attached to the winding lead.
11. Attach the new terminal with a large electrical crimping tool.
Trane-Pueblo uses a Thomas & Betts TBM5 compression tool (die number 13455). **Black die**
