ECM module is not communicating with UC400 or Symbio 210. IMC comm down. Unable to Softset ID

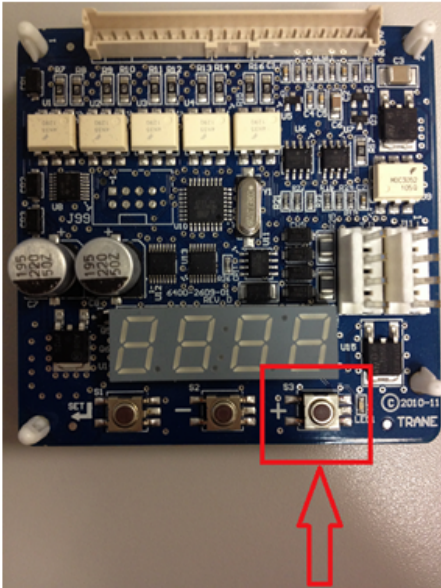
2. Prior to clicking OK, activate the engine module using the (+) button on the ECM engine board in the control box.
Once the engine module is activated, the LED to the right of the (+) button lights up.

3. Once the light has been activated, click **OK** on the Softset Rotary Address - Expansion Module dialog box shown in step 2.
When you click OK, Tracer TU softsets the engine module IMC address to 99 and the light on the module will turn off.

4. Return to the Expansion Module Status box, click **Discover** and wait five to ten seconds for Tracer TU to refresh the screen.
Once complete, the value in the Error column updates to None and the Status column updates to Comm Up.
