General Service Bulletin

HCOM-SB-85

35-60 Ton Helical Rotary Compressor Motor Terminal Retrofit

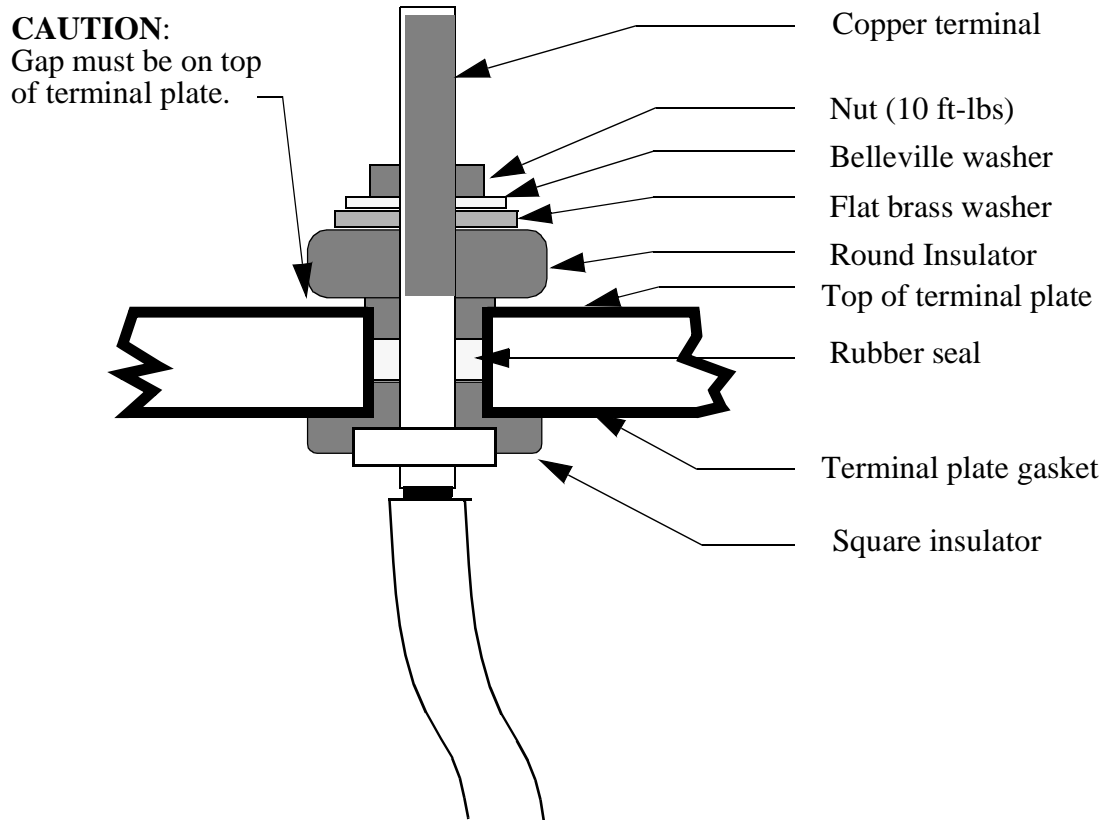
Figure 1. Description of Motor Terminal Insulator Retrofit

The original insulators used on the 35-60 ton helical rotor compressor motor terminals may leak due to slight variations in the terminal plate. Rather than re-designing the terminal plate, the motor terminal stud insulators were re-designed to be more tolerant of variations in the terminal plate.

The original insulators were also installed with steel nuts and washers. If the compressor is located in an environment with high humidity the steel nuts and washers will rust. The rust can travel down the terminal and across the insulator. This path can cause the compressor to short to the terminal plate.

NOTE: The following are brief steps for removing and reinstalling only the insulators around the motor terminals. Refer to RTAA-IOM-4A for further details on electrical and refrigerant issues. Refer to Figure 1 for assembly details.

5. Remove the terminal plate.
6. Inspect components for scratches, etc. that may cause a leak.
7. Remove lower insulator.
8. Begin reassembly by replacing lower insulators

- (green) with the square black insulator making sure the terminal post is seated in the insulator.
9. Replace o-rings with the rubber seal.
10. Oil and install new terminal plate gasket.
11. Carefully push terminals through the terminal plate.

12. Install upper insulator (round, black).
13. Place flat brass washer on top of the upper insulator.
14. Place belleville washer on top of the flat brass washer such that the outside edges of the belleville touch the flat washer.
15. Hand tighten the nut. Do not exceed 10 ft.-lb. on the nut. Refer to Figure 1 for the assembly of the new insulators.
16. Reconnect the spade connectors for the motor temperature sensors. Follow the color coding of the sensors.
17. Install the terminal plate on the compressor with the 12 mounting bolts. Follow the torquing sequence as shown in Figure 2.
18. Torque the terminal plate mounting bolts to 40 ft.-lb.
19. Torque the terminal stud nuts to 10 ft.-lb.
