TRANE™

General Service Bulletin

RTHA-SB-19

Subject: RTHA bF2 Low Oil Flow Diagnostic.

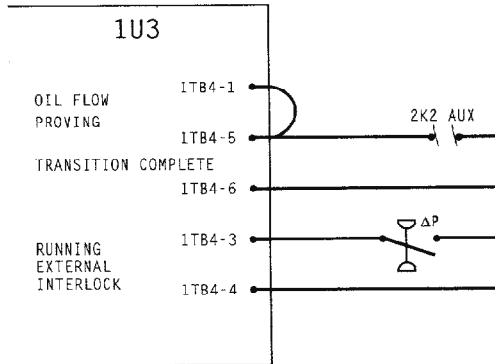
Figure 1
Differential Pressure Switch Rewiring for
Units Without Active Oil Return

6. If none of the above steps eliminate the bF2 nuisance trips, then the differential pressure switch needs to be rewired. This is done to help distinguish what is actually causing the trips.

For units without active oil return, refer to Figure 1 and follow the procedures below:

- a. Remove the Delta-P switch from 1TB4-1 and 1TB4-5 and place a jumper between these two terminals.
- b. Change the Delta-P switch from normally-closed to normally-open.
- c. Rewire the Delta-P switch to the "Running External Interlock" terminals, 1TB4-3 and 1TB4-4.
- d. Restore power and proceed to Step 7.

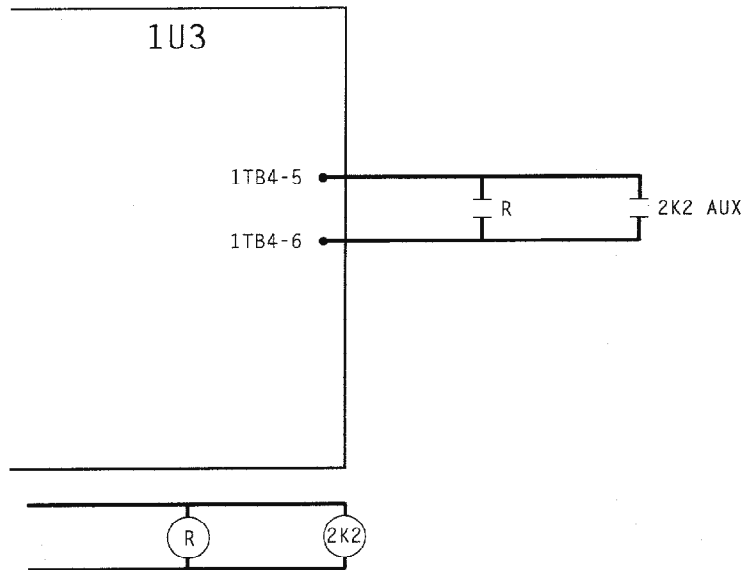
Figure 3
Additional Relay to
Eliminate Chattering of 2K2 Aux.

If the nuisance "bF2" diagnostics still occur an additional relay must be added.

R = Additional relay with a dry DC circuit rating.

10. The additional relay must have contacts rated for a dry DC circuit. RLY-847 can be used for this purpose.

Wire the relay coil in parallel with the 2k2 contactor coil, with the N.O. contacts of the relay wired in parallel with the 2k2 auxiliary contacts. Refer to Figure 3 for details.

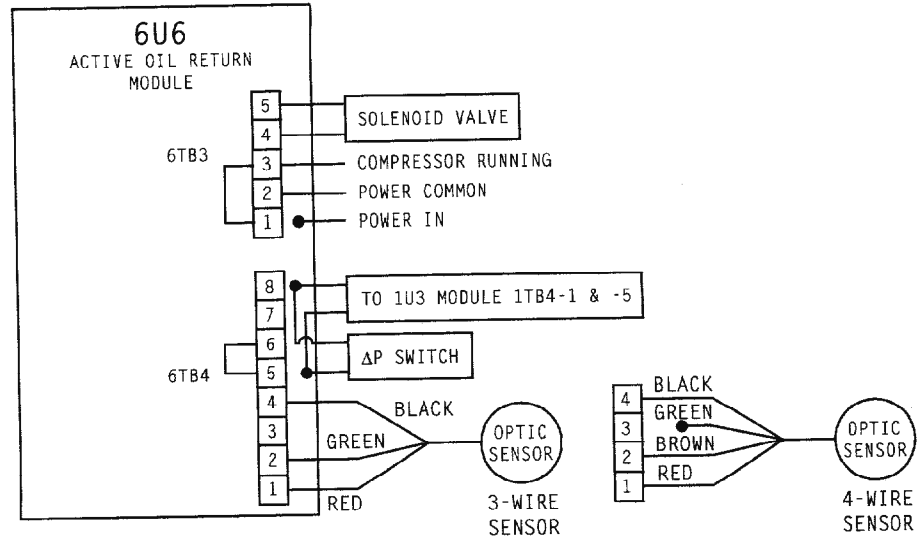
**Figure 6
Re-Wiring of the 6U6 Module**

With the modifications to the actual piping completed, the unit will bring more oil and refrigerant back to the compressor. This can cause excessive foaming in the oil tank, confuse the optical sensor and, if the re-wire is not completed, cause the unit to trip off line.

Refer to Figure 6.

1. Be sure that all power to the Control Panel is de-energized.
2. Disconnect the wire at 6TB3-1 and cap the wire.
3. Install a jumper wire between 6TB3-1 and 6TB3-3.
4. Disconnect the wires at 6TB4-6 and 6TB4-8, tie them together and cap them.
5. Disconnect the wires at 6TB4-5 and 6TB4-7, tie them together and cap them.
6. Install a jumper wire between 6TB4-5 and 6TB4-6. Terminals 6TB4-7 and 6TB4-8 will remain bare.
7. Restore power to the Control Panel.

The re-wire of the 6U6 module will allow the differential pressure switch to continue protecting the unit from a restriction in the hydraulic line. The change is in the operation of the Active Oil Return module (6U6).
