Engineering Bulletin

# Aluminum Fin Surface Oxidation on Air-Cooling Coils

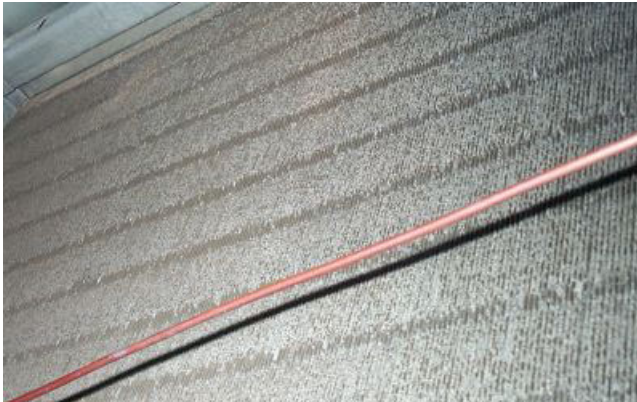
**Figure 1.** Looking at the leaving airside of a coil, aluminum oxidation can be seen uniformly across a heavily oxidized fin surface.

Replacing the affected coil with coated aluminum fins eliminates the problem. Common coatings would be some type of corrosion resistant coatings that are optional on some product lines. While this is easily accomplished in residential equipment, much more effort, time and cost is involved in replacing coils in large commercial equipment.

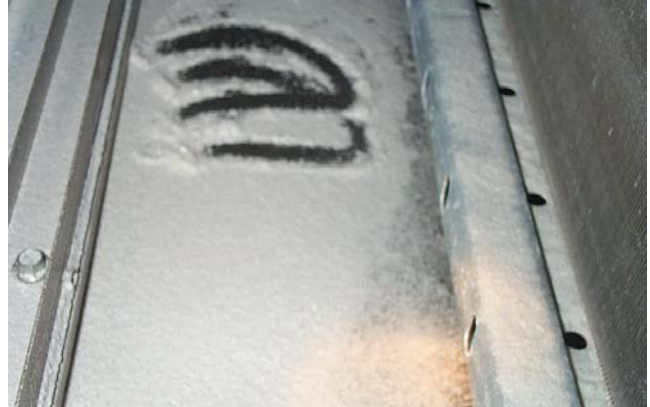
**Figure 2.** Drainpans are typically the first place that flakes accumulate. The amount of powder found can be noteworthy especially when no detectable breakdown of the fin surface is observed.

From a customer standpoint, the main complaint has been the house keeping issues of having white powder distributed from the HVAC ducts and diffusers. Post filtration or final filtration has been successfully applied in containing the flakes within the air handler systems or duct work. While not all systems will be conducive to applying additional filtration, it has been shown that very minimum particle efficient filters are more than capable or remove the large white flakes from the airstream. Field experience has shown that coil cleaning at best offers only short term relief as the flake production will inevitably return.

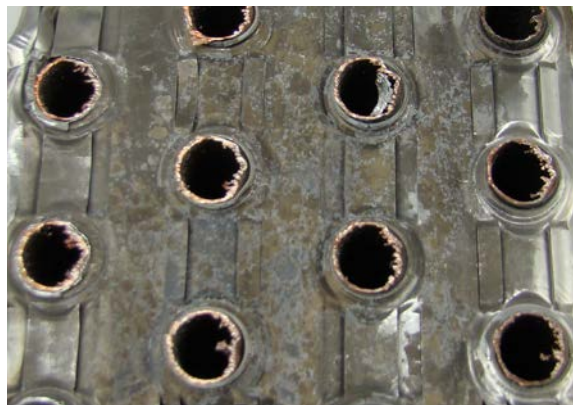
**Figure 3. A close-up view of the fin surface shows the blackening and corrosion phenomena.**
